# Structural Testing of Geopolymer Pipe & Culvert Mortar Lining System

<b>David Keaffaber, P.E.</b>	Midwest Region Manager Milliken Infrastructure Solutions, LLC
<b>Joseph Royer, PhD</b>	Development Manager Milliken Infrastructure Solutions, LLC
<b>Dan Koo, P.E., PhD</b>	Assistant Professor IUPUI Construction Engineering & Management Tech.

Purdue Road School - March 2015

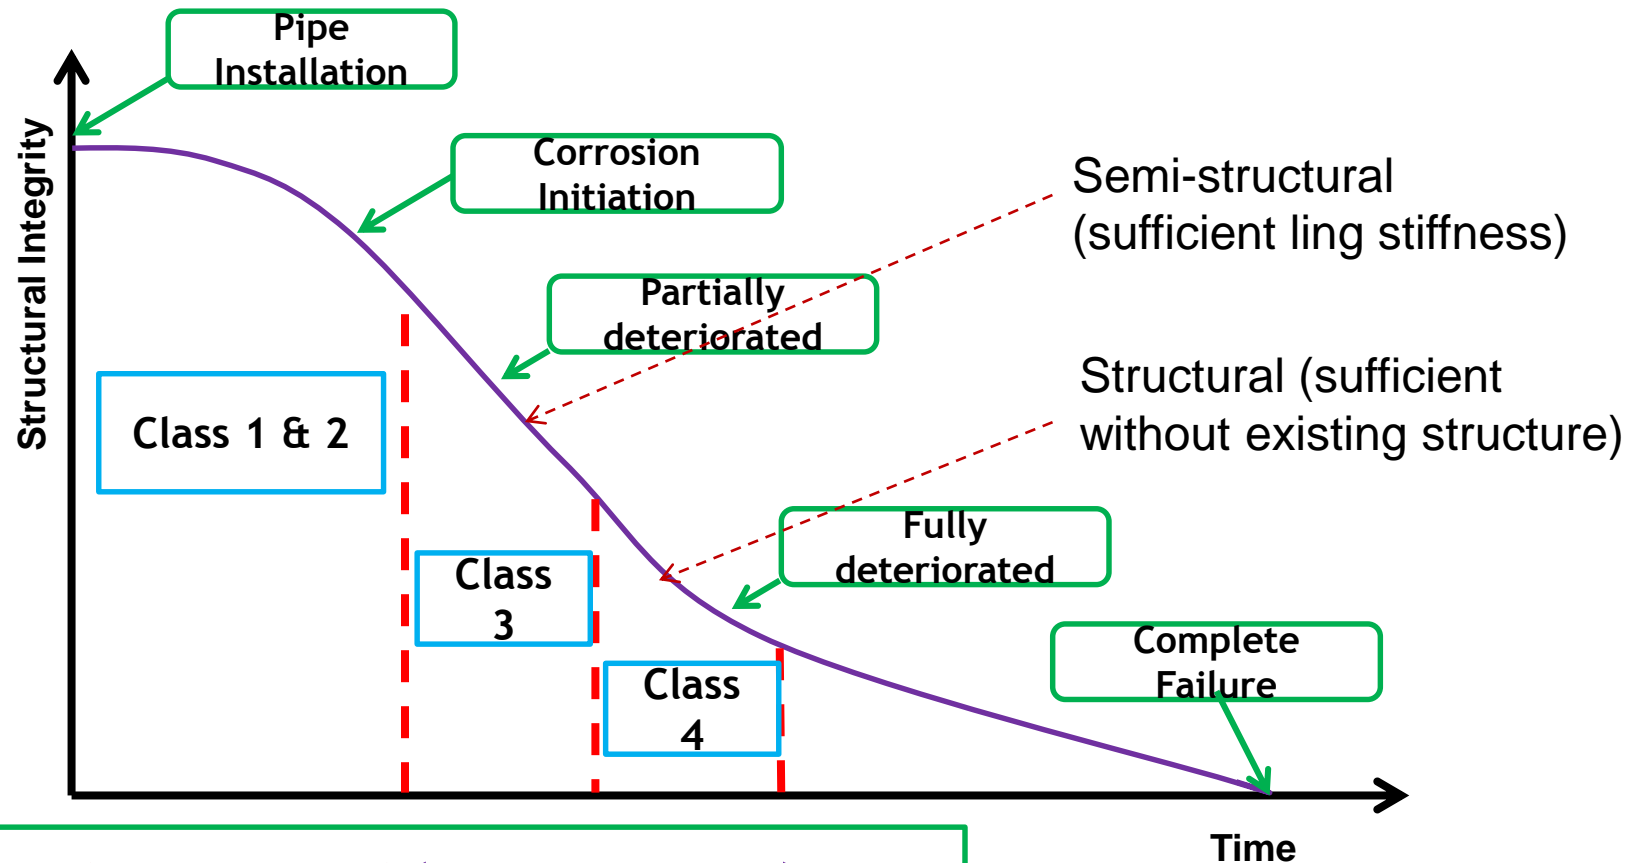
### Structural Condition Progress

- Polymer Lining
- Cement Lining

- Geopolymer Lining
- Sliplining
- Spiral Wound Lining
- CIPP

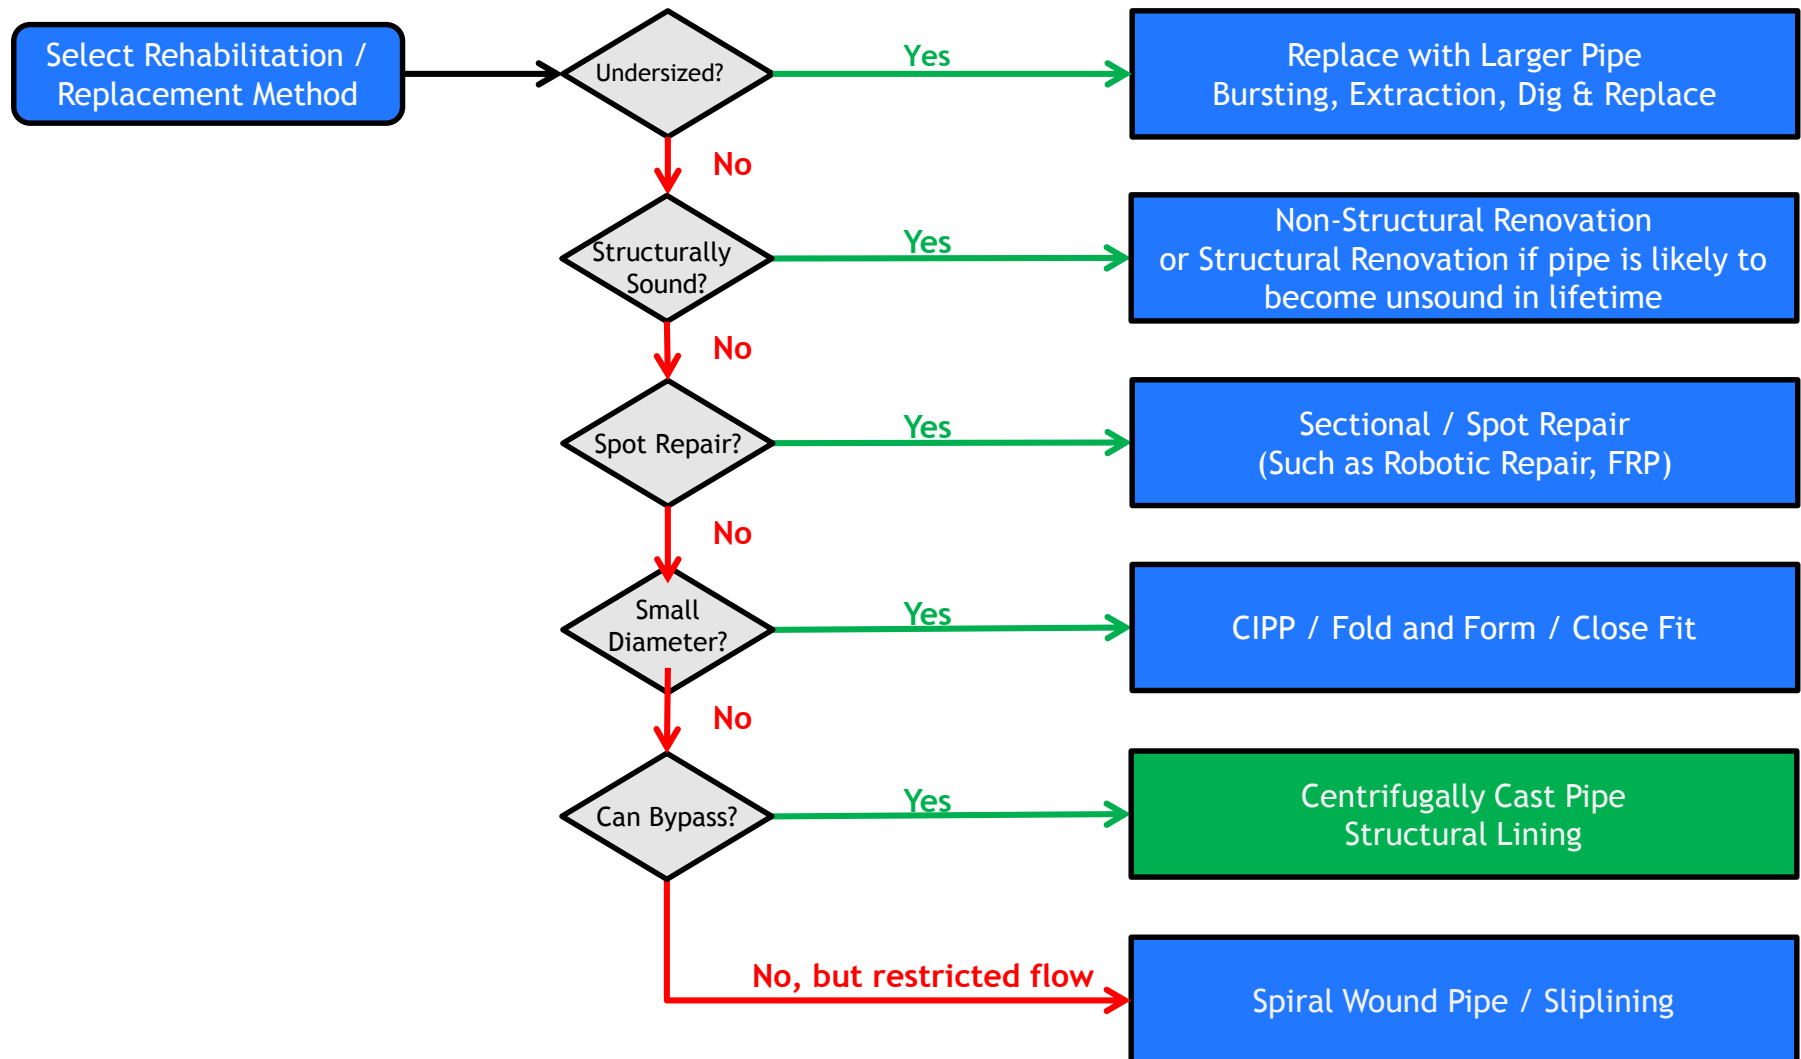
## Simplified Method Selection

Choosing a method of renovation involves understanding the current status, size, type, intended service conditions and life expectancy of the pipe to be repaired.

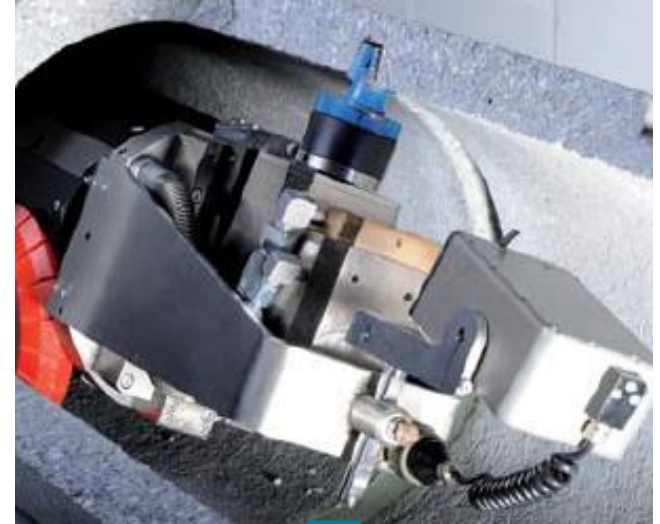
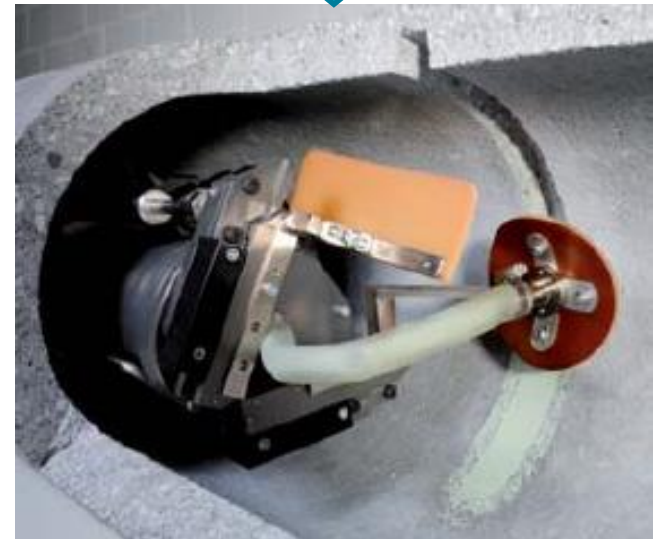
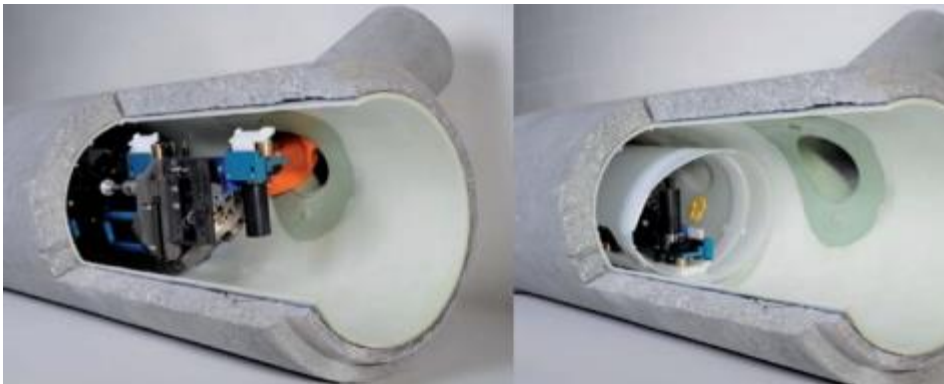
## Robotic Repair

- Robotic repair is mainly used to eliminate cracks in pipe. the robot grinds and then filled the area with polymers such as epoxy mortar.
- Suitable for small diameter pipes.
- Can be used any shape of pipes.
- Tools and robots are expensive.

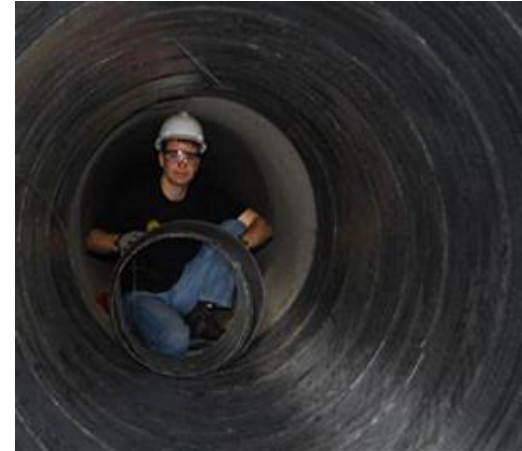
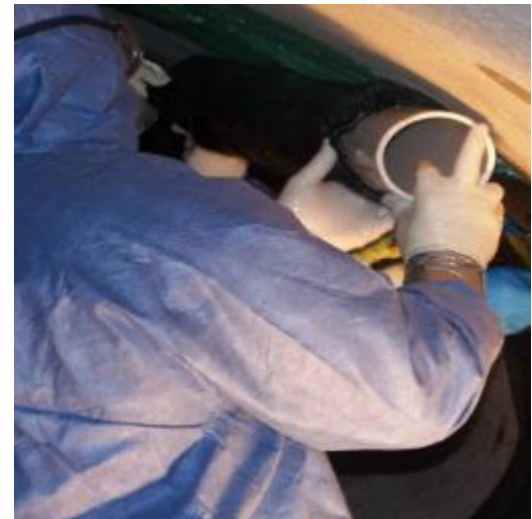
*Carbon Fiber Wrap of Concrete Pipe*

**Fiber Reinforced Plastic (FRP)** is the industrial term used to describe the use of carbon or other high strength fiber combined with an epoxy matrix to reinforce an existing structure. While this technique is classified as a structural repair and can be used to increase the structural integrity of the host pipe, it does rely on the host pipe to provide some of the structural requirement.

Carbon fiber strips are applied by hand or with machines almost like wallpaper with an epoxy matrix that is specially formulated to bond to the host pipe and create a composite structure. This technique is primarily advantageous for spot repairs due to the material cost.

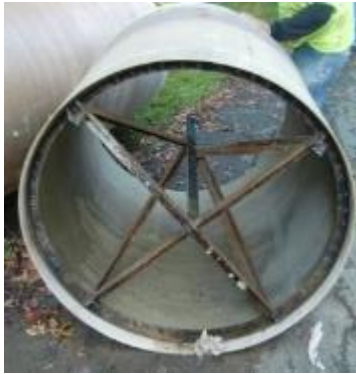
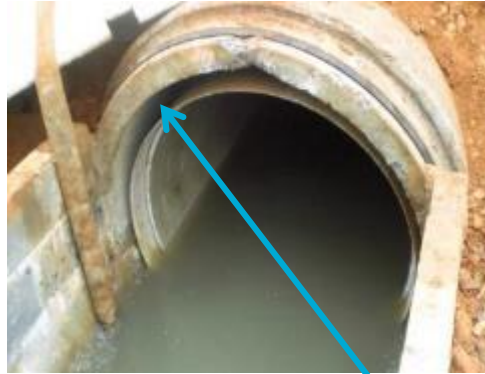
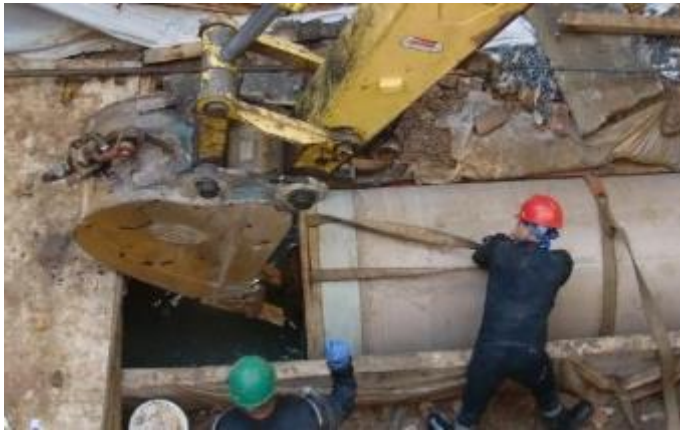
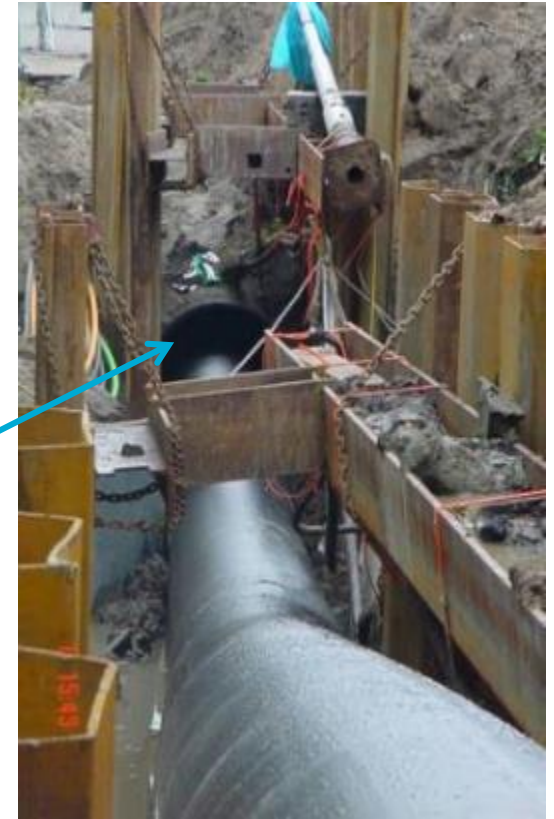
## Conventional

Annular Space

- Sectional (Discrete) Pipes
- Continuous Pipes

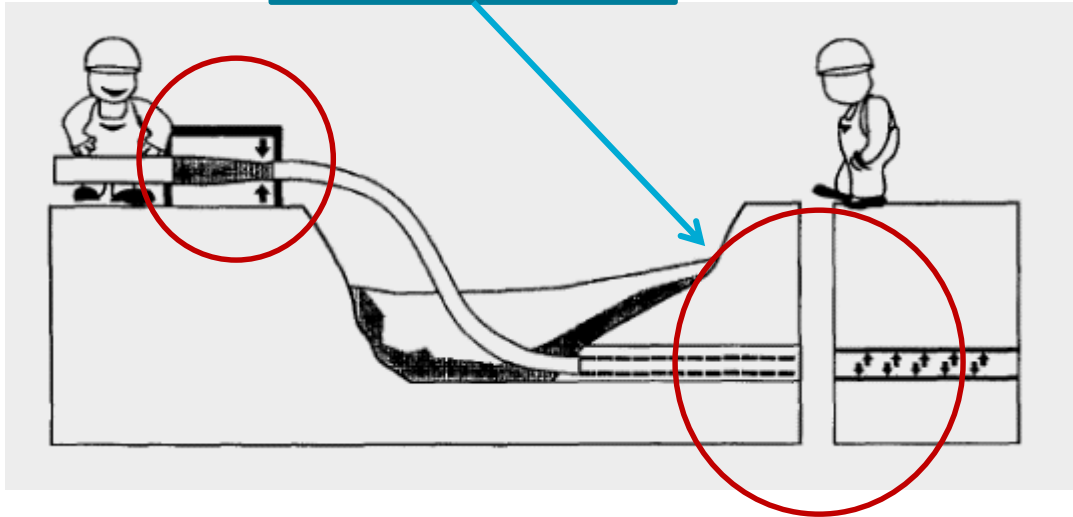
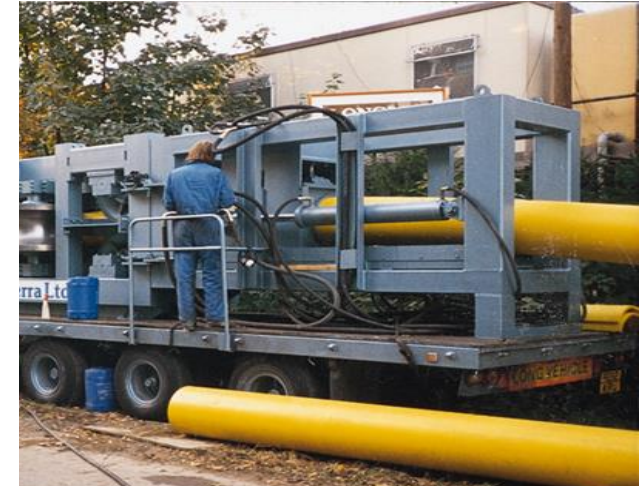
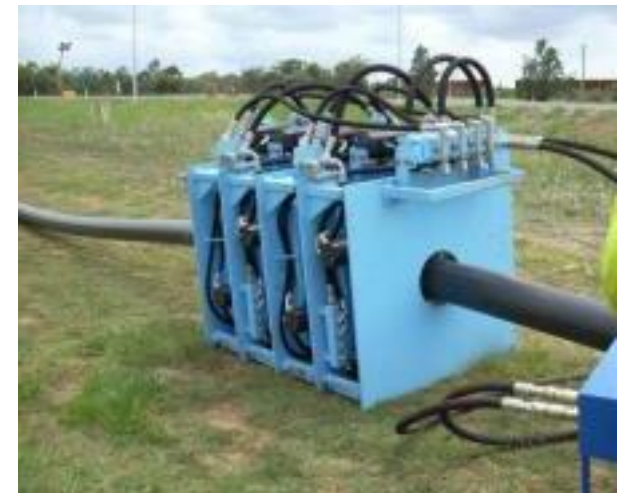
Close Fit

Lining with a continuous pipe for which the cross section is reduced to facilitate installation and reverted after installation to provide a close fit to the existing pipe

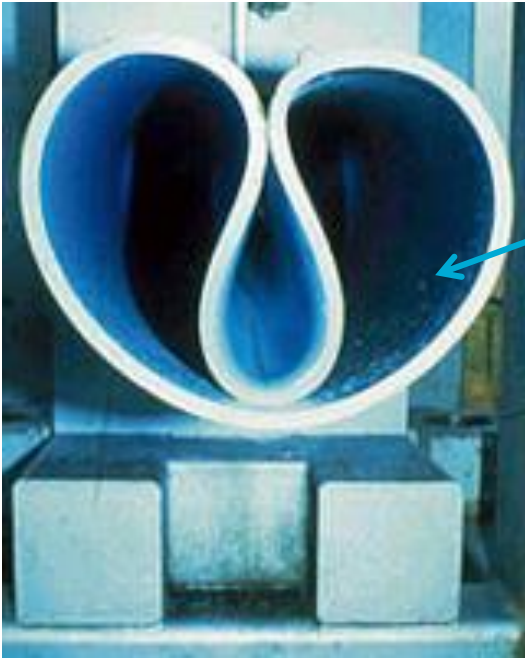
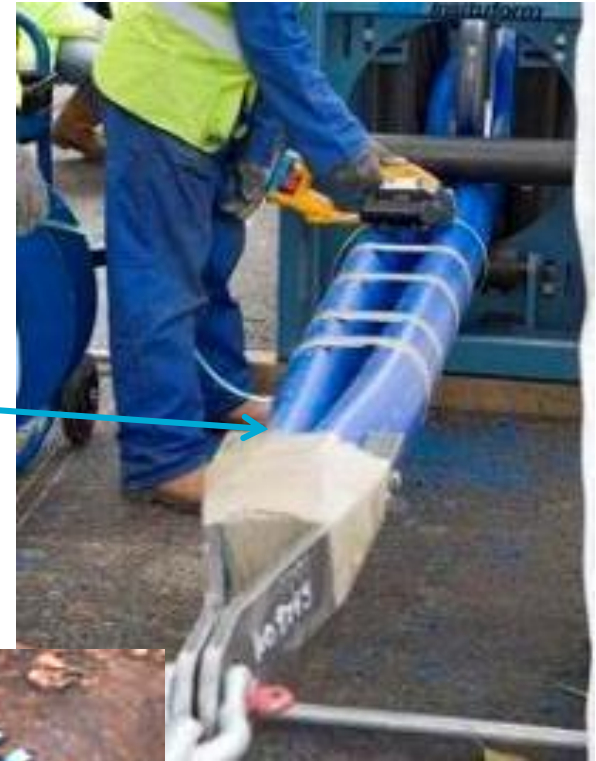
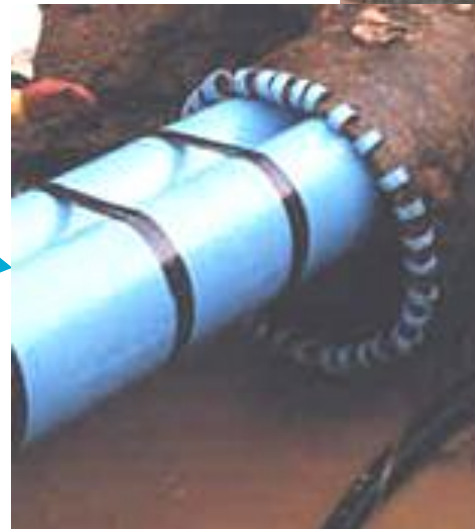
## Fold and Form

Fold

Temp.  
Bending

FORM  
reverted after installation  
to provide a close fit to  
the existing pipe

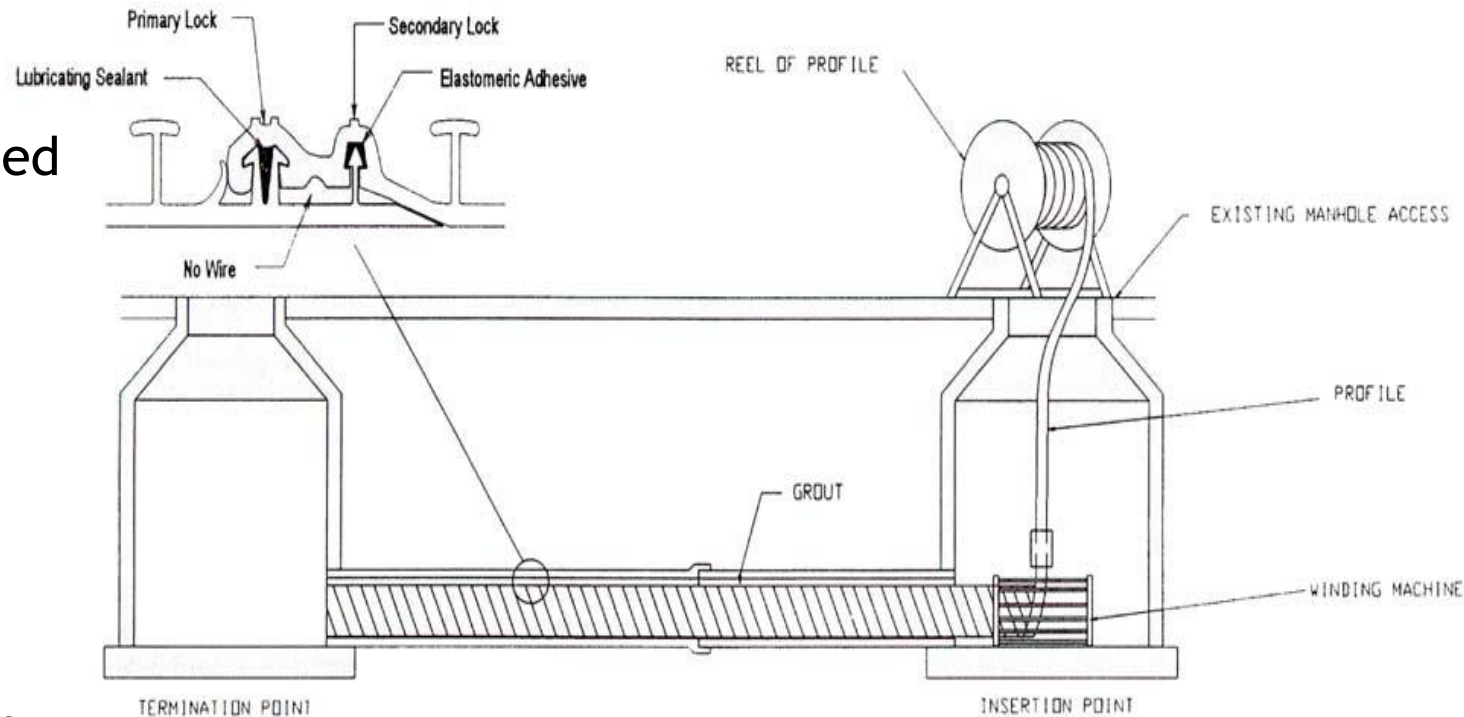
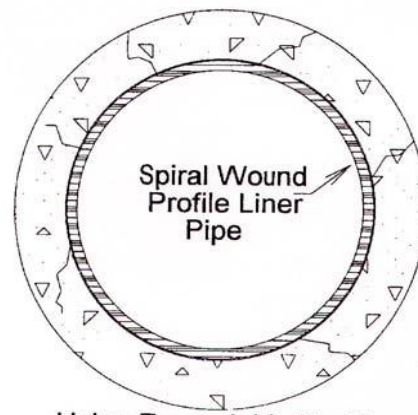
- Ribloc developed in Australia in 1980
- Originally formwork for cast in place pipe
- Mostly used for medium to large size sewer
- Low pressure rating

Using Expandable Profile Liner Pipe Pressed Against Existing Pipe Wall

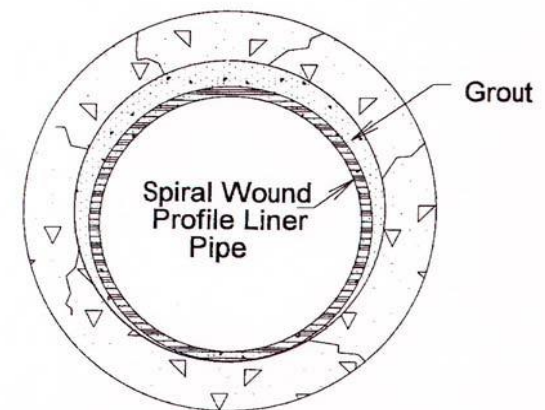
Using Fixed Diameter Profile Annular Space Filled With Grout

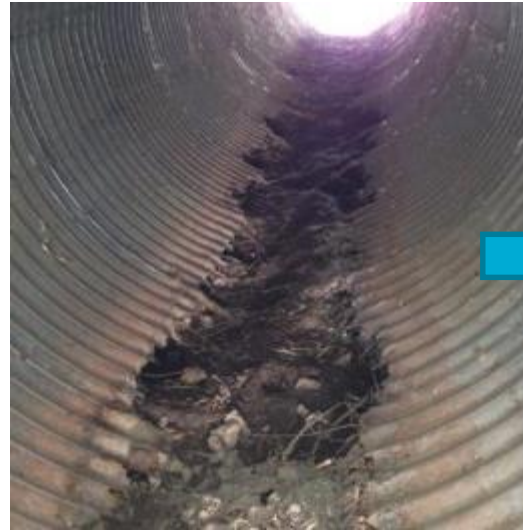
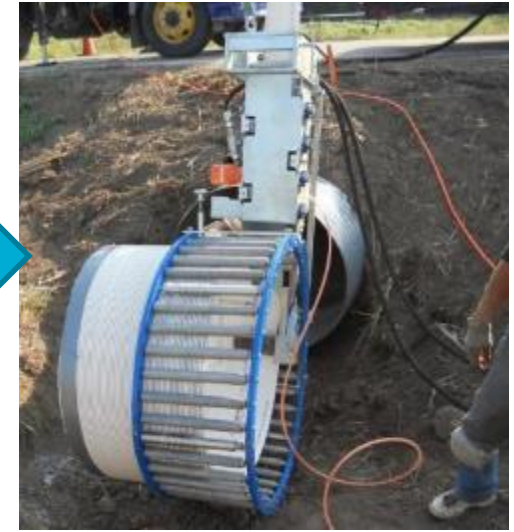
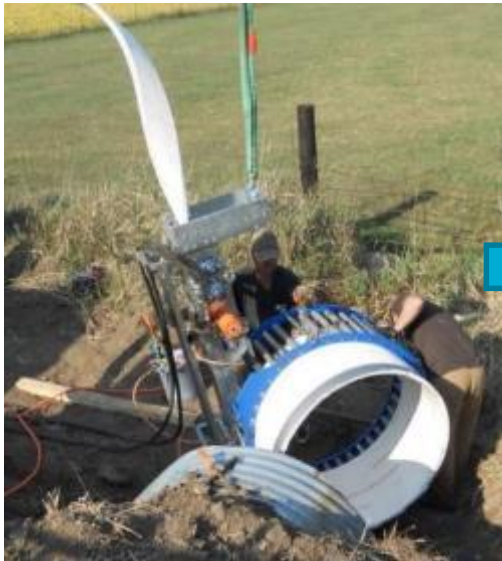
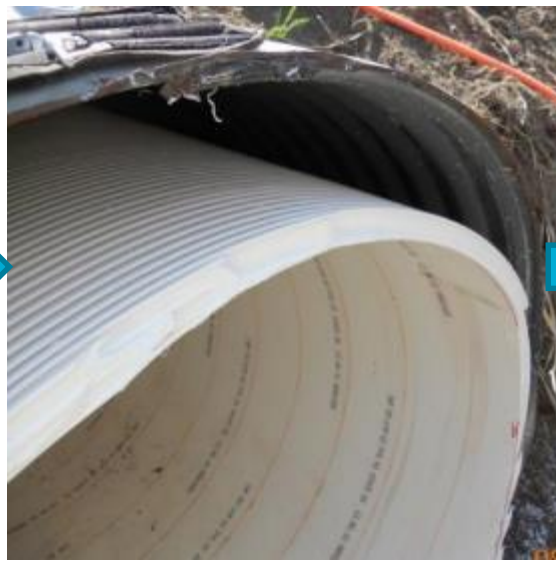
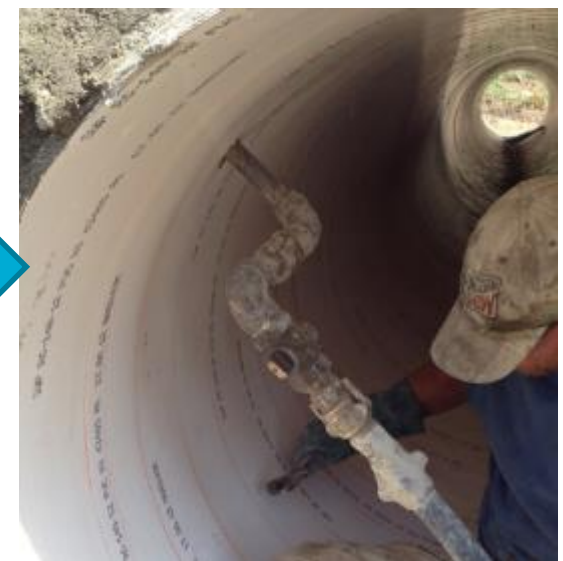
## Example

SWL for medium and large diameter circular / non-circular roadway culverts rehabilitation.

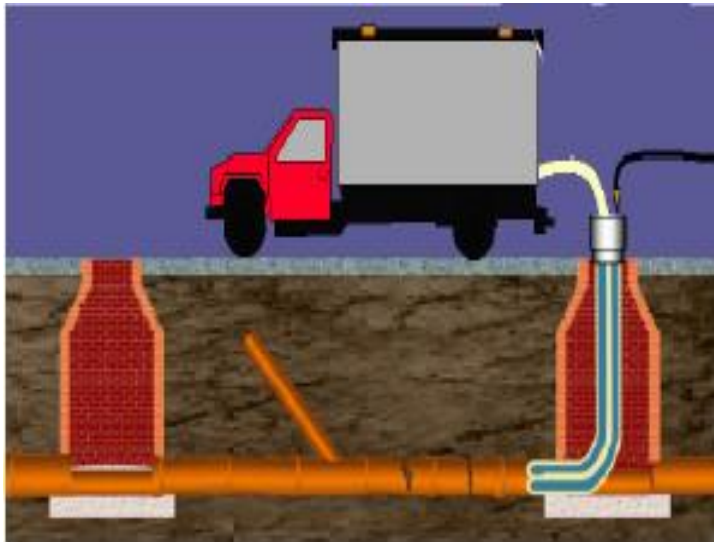
**Inversion Process**

- Most popular trenchless lining technology
- Invented in 1971 in the U.K. (Eric Wood)
- Lining with flexible tube impregnated with thermosetting resin
- Can be used for both partially and fully deteriorated condition
- Gap spanning

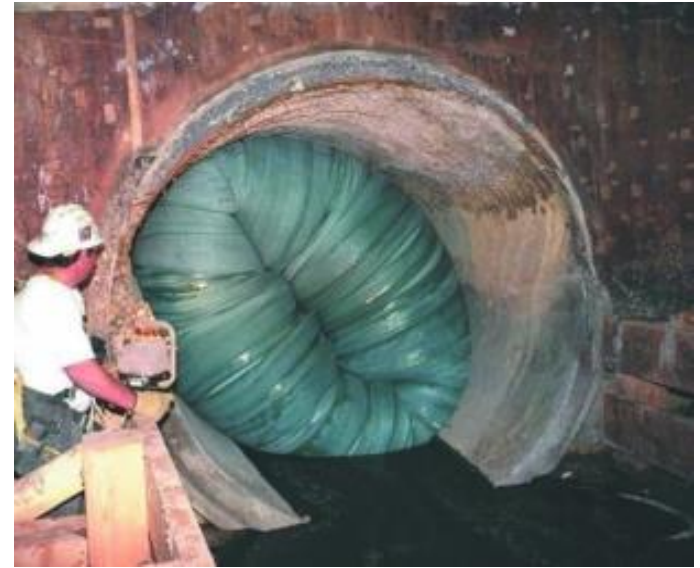
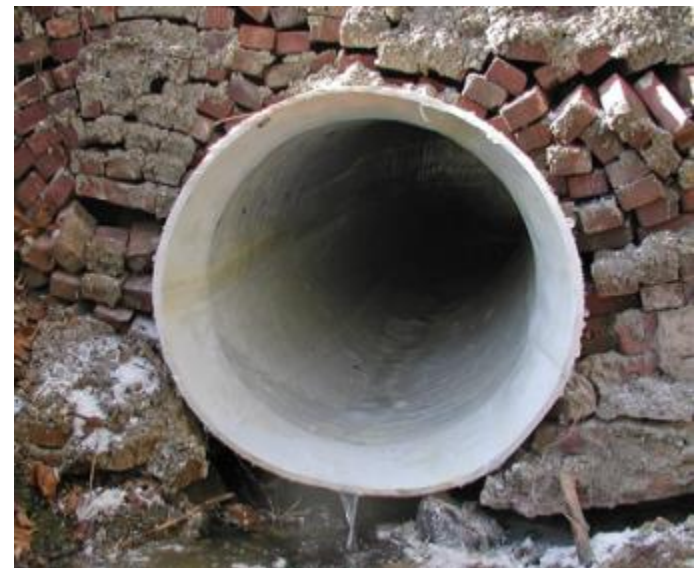
- May be installed to reduce infiltration/exfiltration
- May be installed to resist external load
- May be installed as a bonded lining for corrosion protection
- May be a **semi-structural** lining for hole and gap spanning
- May be a **fully structural** lining designed to support structural loads and restore fabric
- Performance will depend on bonding, thickness, and reinforcement

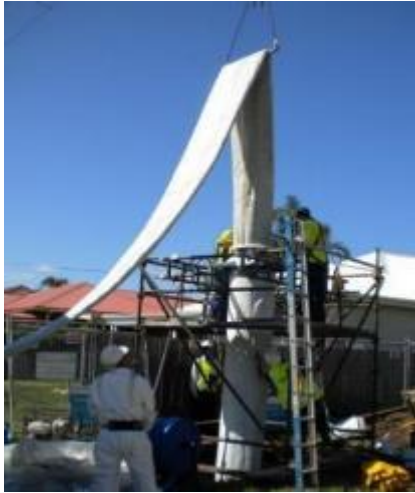
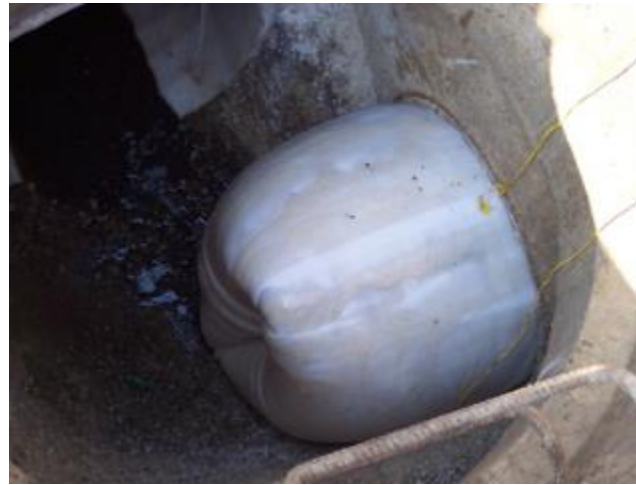
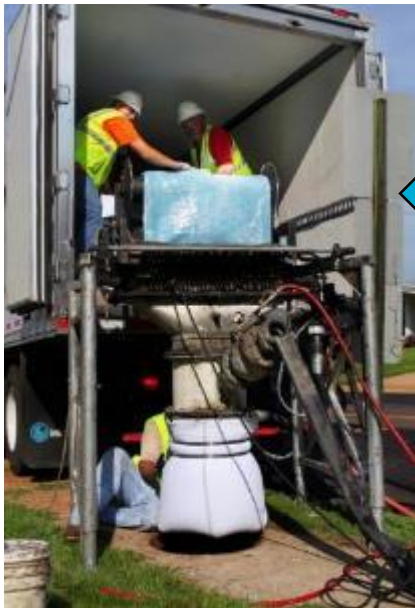
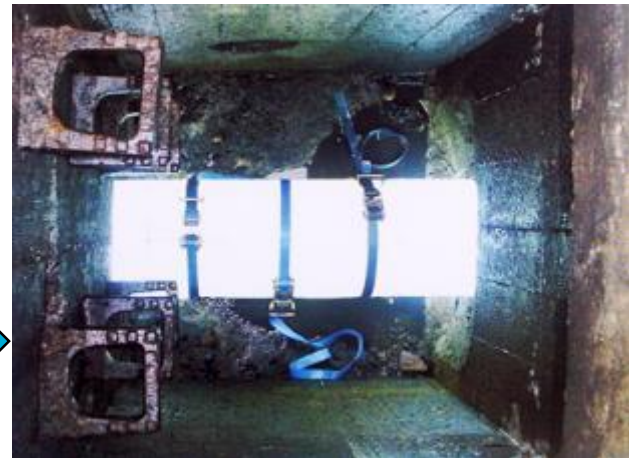
## Curing Processes

UV curing →

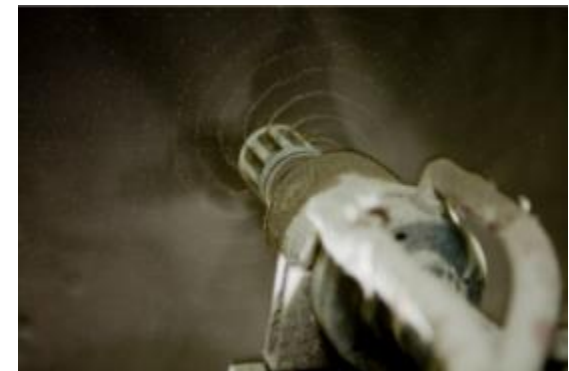
**Centrifugally Cast Pipe** employs a similar spin casting process as a non-structural mortar lining, but cementitious materials is applied to a thickness that creates structural integrity of a whole new pipe within the host structure. Typical wall thickness of structural cementitious mortars range from 1½ inches to 4 inches depending on the specific design requirements and service application of the pipe.

*GeoSpray™ Centrifugally Casting  
in Action*

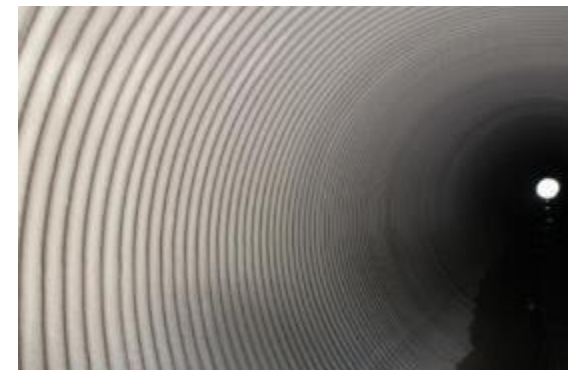
*Close-Up View of GeoSpray™ Liner*

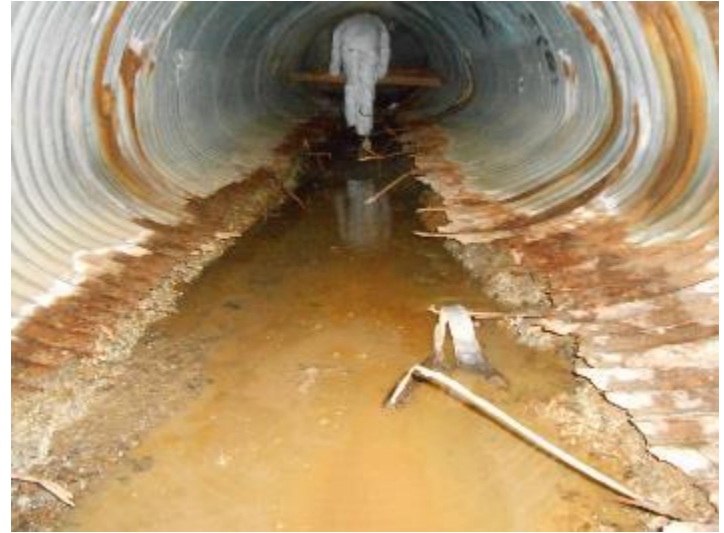
The initial culvert was in very poor shape with most of the invert corroded and lost with soil voids as deep as 2 ft below the pipe

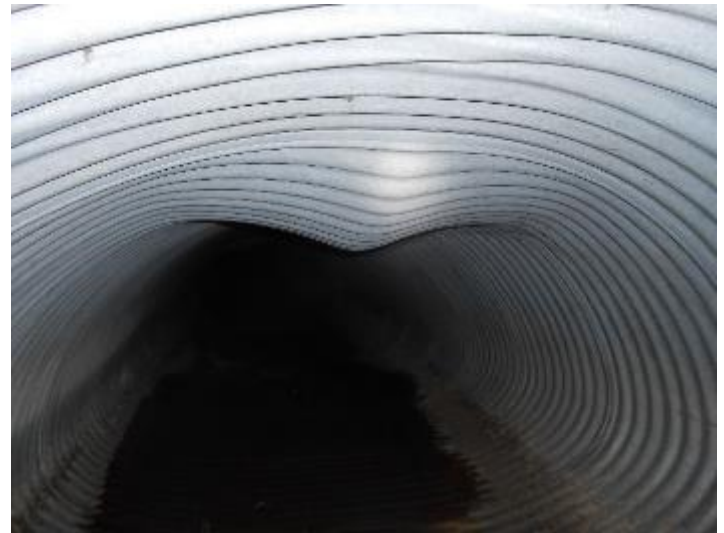
Significant damage also existed in the crown with some sections caved in.

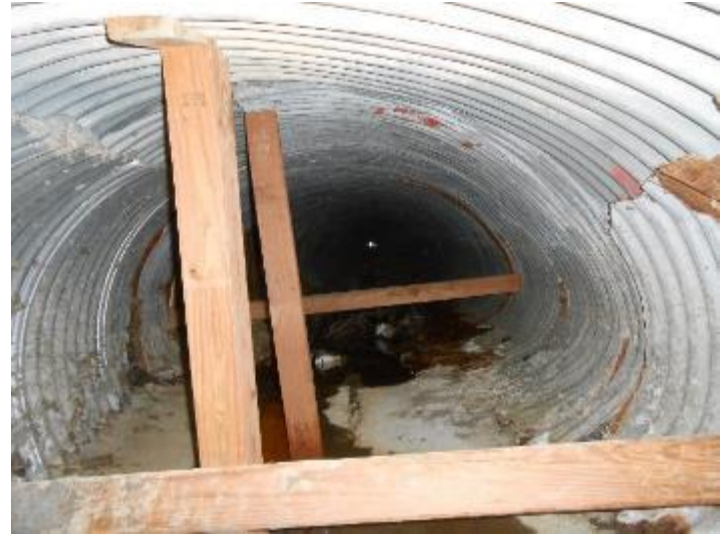
Prior to repair the pipes required bracing for safe operation.

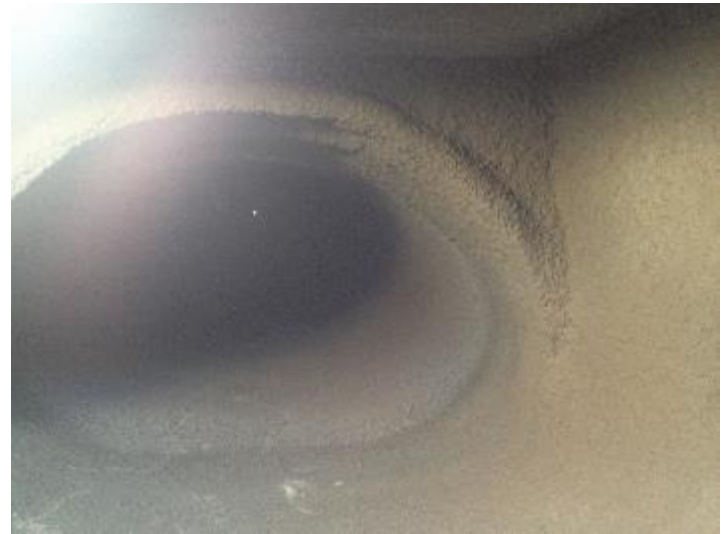
The finished culvert created a new structural system, integrated with the junction boxes

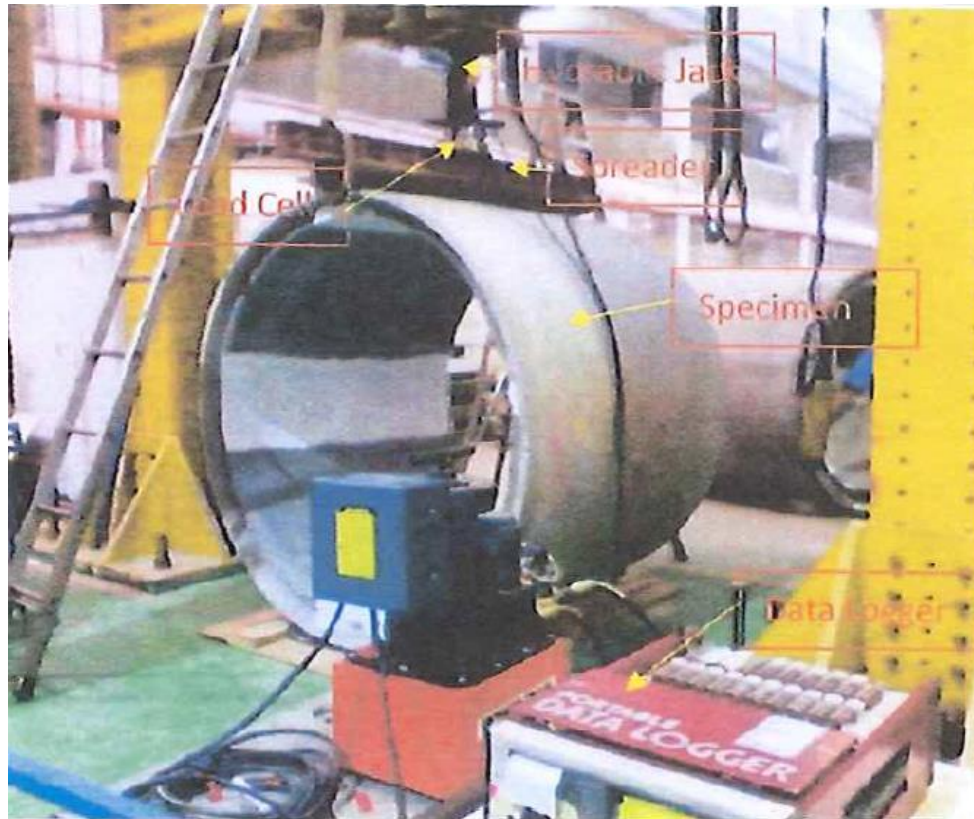
## 4 New RCP Test Pipe Samples\*

Outer Diameter = 1.7 M (~67 inch)

- 4 new RCP pipes 1.7 m (~67 inch) outer diameter, 1.5 m (~59 inch) inner diameter with a wall thickness of 200 mm (~8 inch) and 1 m in length (~ 39 inch) were coated with GeoSpray geopolymer mortar under the following conditions:
  - » Sample 1 - Control Pipe - No Coating
  - » Sample 2 - 50 mm (~2 inch) nominal coating
  - » Sample 3 - 38 mm (~1.5 inch) nominal coating
  - » Sample 4 - 38 mm (~1.5 inch) nominal coating with additional reinforced wire mesh
- Test were conducted under the following Malaysian standard
  - » MS 881: Specification for Precast Concrete Pipes and Fittings for Drainage and Sewerage.
  - » Part 3: Specification for pipes and fittings with Ogee Pipes
  - » Appendix F: Crushing strength test for pipes.

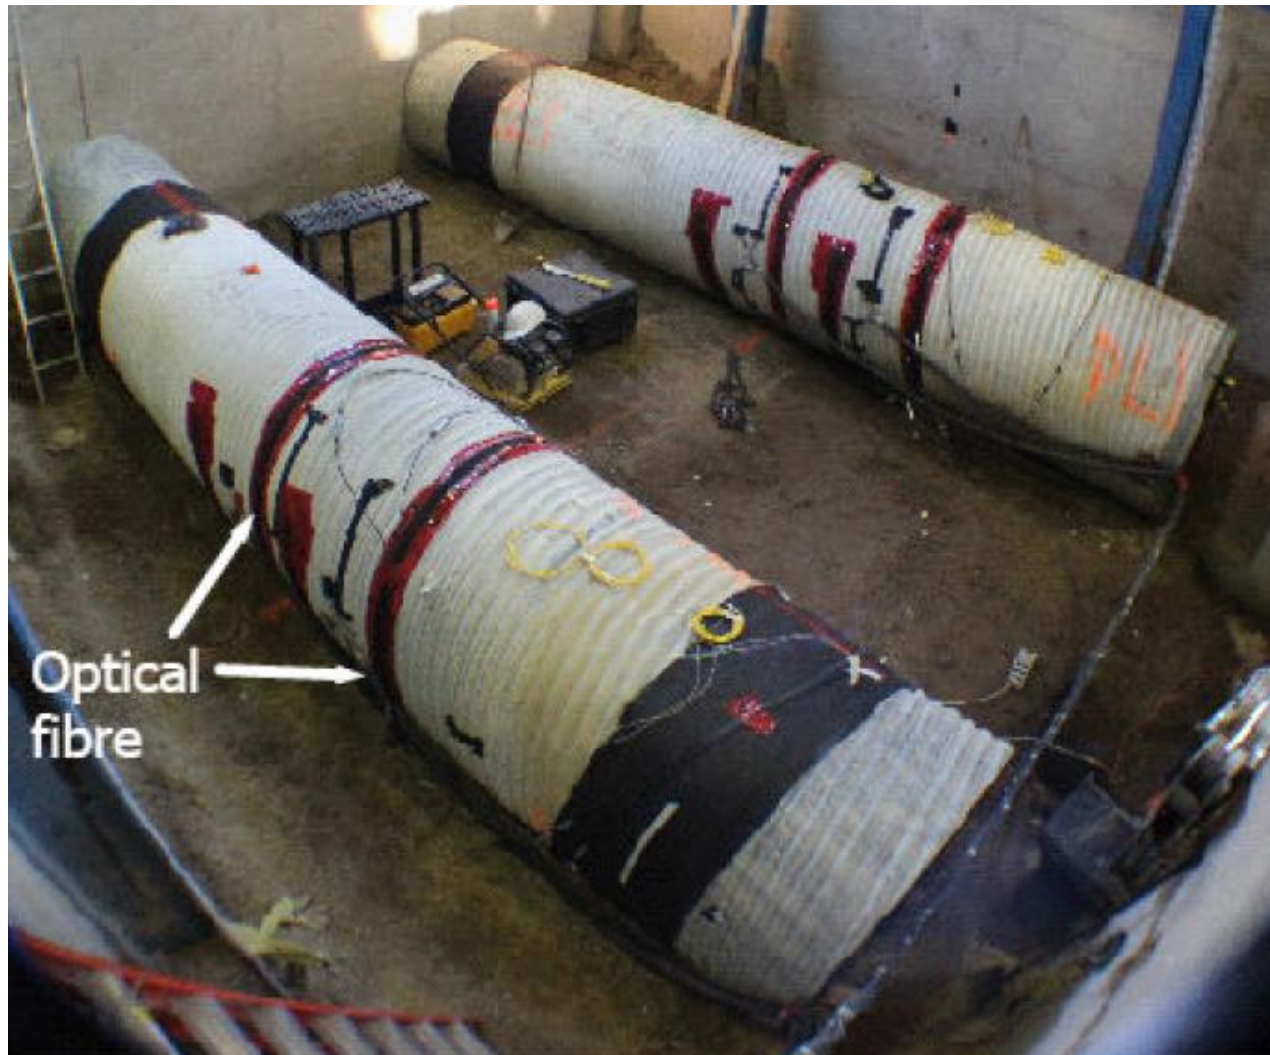
Assembled and instrumented culverts prior burial and testing

- 3 damaged and deteriorated CMP culverts were excavated from the E407 Toll Road in Ontario, Canada.
- Two - 1200 mm (~48 inch) in diameter, 7 m (~23 ft) long culverts were assembled and buried in the laboratory under controlled soil fill conditions.
- The assembled culverts were tested under Canadian Highway single axel loads standards under a burial depth of 1200 mm (~48 inches)
- The 2 culverts were then repaired with GeoSpray geopolymer mortar lining with nominal thickness of 50.8 mm (~2 inches) and 76.2 mm (~3 inches).
- The culverts were allowed to cure for 28 days.
- Testing of the culverts was performed under single and double axel loads with buried depths of 1200 and 2100 mm (~48 and 83 inches) respectively.
- Finally, the culverts were loaded to the maximum available load conditions 1200 kN (~270,000 lbs-force).

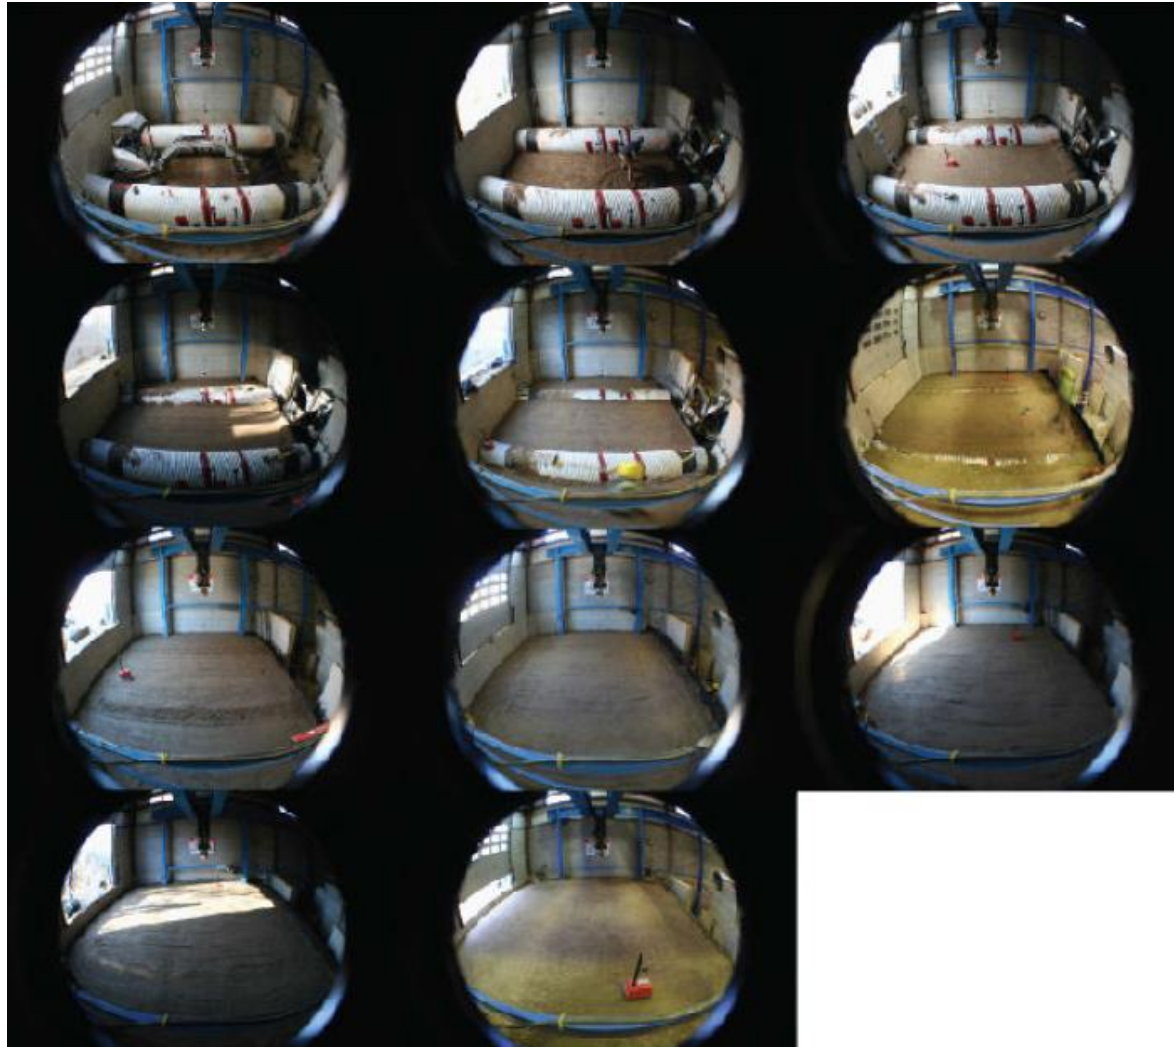
Time lapsed view of culvert burial to 1200 m depth

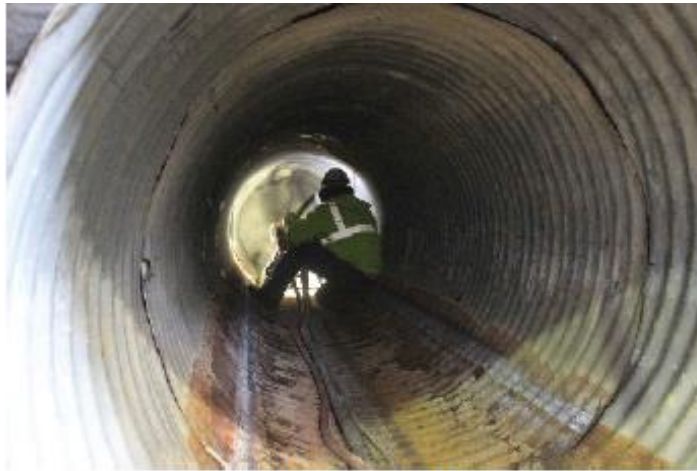
(a) Beginning of repair

Series of images showing in laboratory repair of culverts

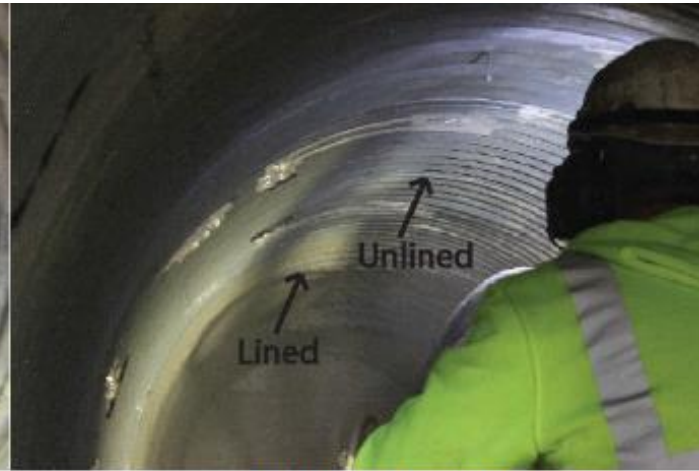
(b) Halfway through first pass

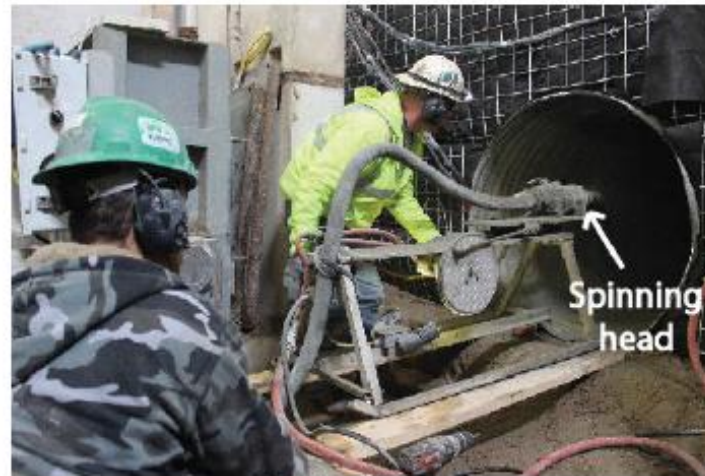
(c) Finishing pass

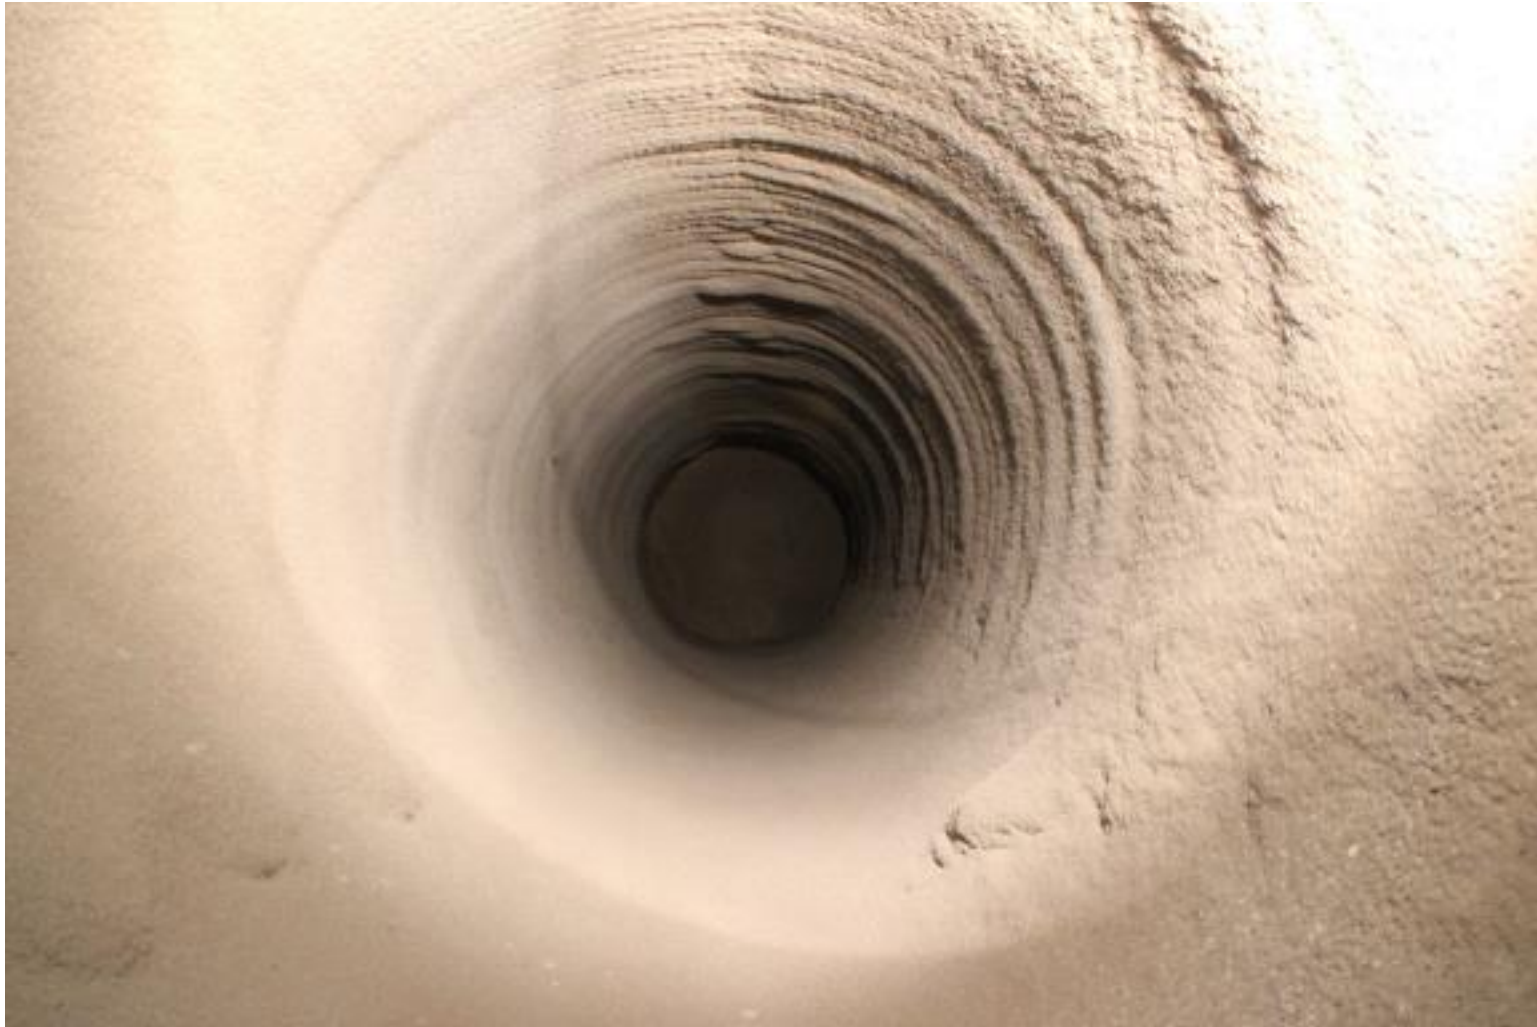
Image of completed culvert repair - in laboratory

- The GeoSpray geopolymer mortar lined culverts were tested under the calculated service loads:
  - » 203 kN - Single Axle Load - 1200 mm fill (~45,600 lbs-force)
  - » 308 kN - Tandem Axle Load - 2100 mm fill (~69,200 lbs-force)
  - » 325 kN - Tandem Axle Load - 1200 mm fill (~73,000 lbs-force)
- Under these conditions, data as to deflection and culvert response was collected.
- No damage was observed or measured under any of the above conditions for either liner thickness.
- Measured diameter changes under these conditions were on the order of 0.2 mm.
